Clawfoot Tub Repair Guide

REPAIRING MINOR TUB BLEMISHES THAT MAY OCCUR IN SHIPPING.

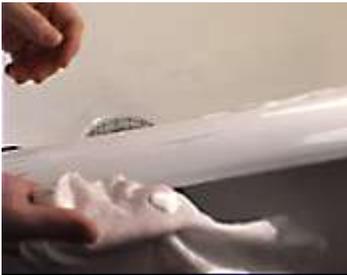
Metal Scuffs on the Porcelain

These are surface marks caused by soft metal rubbing against the porcelain.

- If that fails, use Bon Ami (or other non abrasive cleanser) on a wet rag. Remember - use a feather touch at first and apply more pressure as you go. Only use the force necessary to remove a stain - excess pressure with any cleaner, sandpaper or rubbing compound can dull the tub finish.

- If the mark remains, use a light rubbing compound according to the instructions above.

- If you still have a scuff mark, gently use very fine (1500 or higher) grit sandpaper to remove the mark. Wet the sandpaper and use small, circular motions on the affected area.

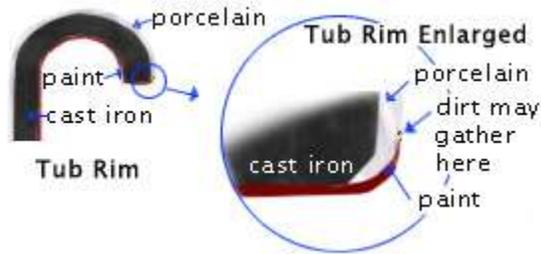
Paint Looks Dirty at the Rim Edge

Sometimes dust and dirt build up on the rim of the tub where the exterior paint meets the porcelain.

- Use a rag to wipe the dirt off with warm soapy water.

- If that does not solve the problem, use rubbing compound on a wet rag. Use small circular motions and only apply enough force to remove the dirt.

- If the dirt still remains, use very fine (1500 or more) grit sandpaper, soaked in water. Using the smallest strokes possible, rub **LIGHTLY** and **ONLY** on the scuffed area. This will smooth the surface between the paint and the porcelain where the dirt was getting trapped.
